BS5837:2012 Tree Survey

**Land at Coylton Substation
Coylton
East Ayrshire
KA18 2RN**

Site: Land at Coylton Substation, Coylton, East Ayrshire, KA18 2RN

Document Reference: BS_030623_SR Revision R1 issued 26 10 2023

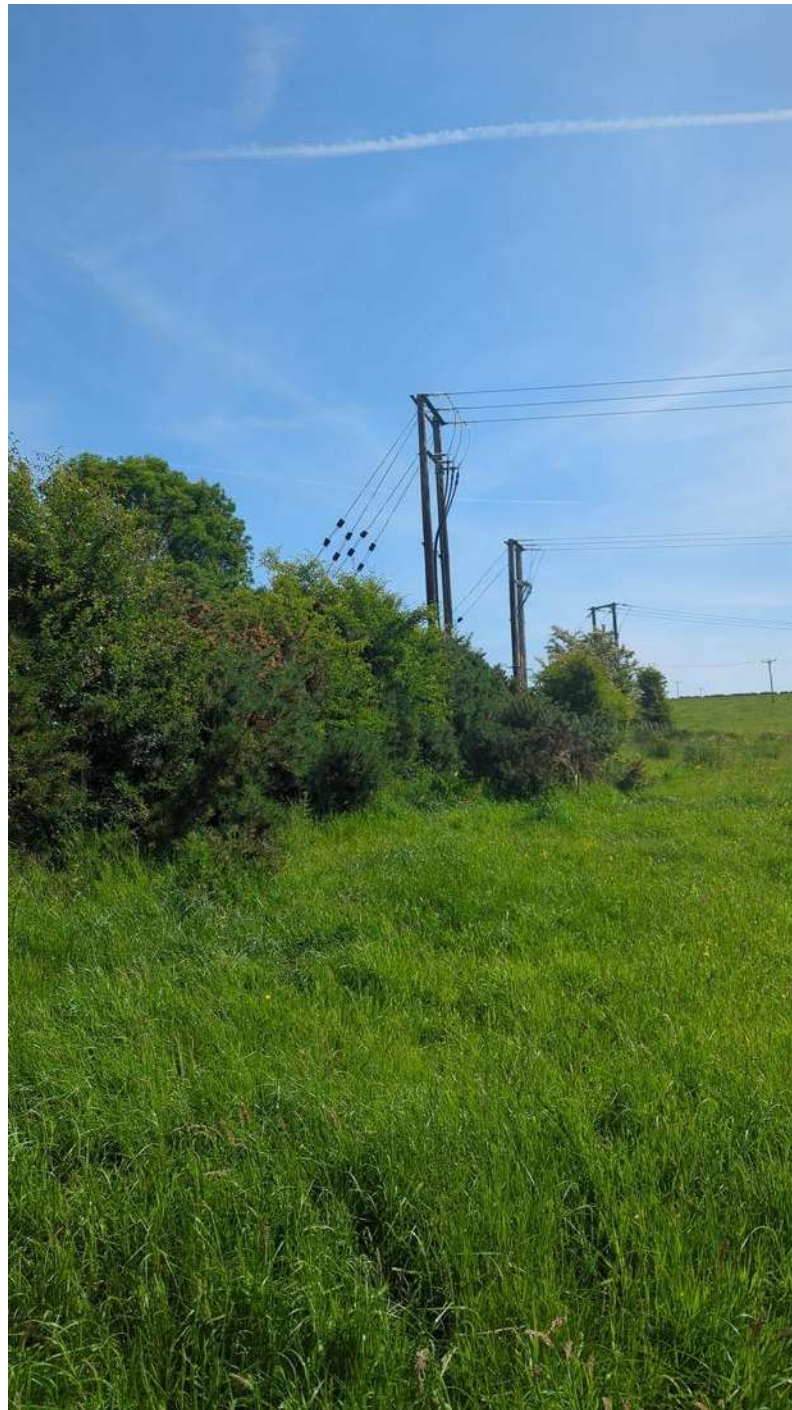
BS_050623 Coylton Substation Image No 01

7.2.1 Comprising outgrown hedging/screening lines, these groups of modest specimens are stable and reasonably well functioning. G1 is graded in the survey and Retention Category C2, whilst G2 is graded at B2. Both feature a substantial

proportion of Scottish native species, and make a significant contribution to the ecological profile of the area. See Image No 01 at Appendix 1, below.

Tree group G1

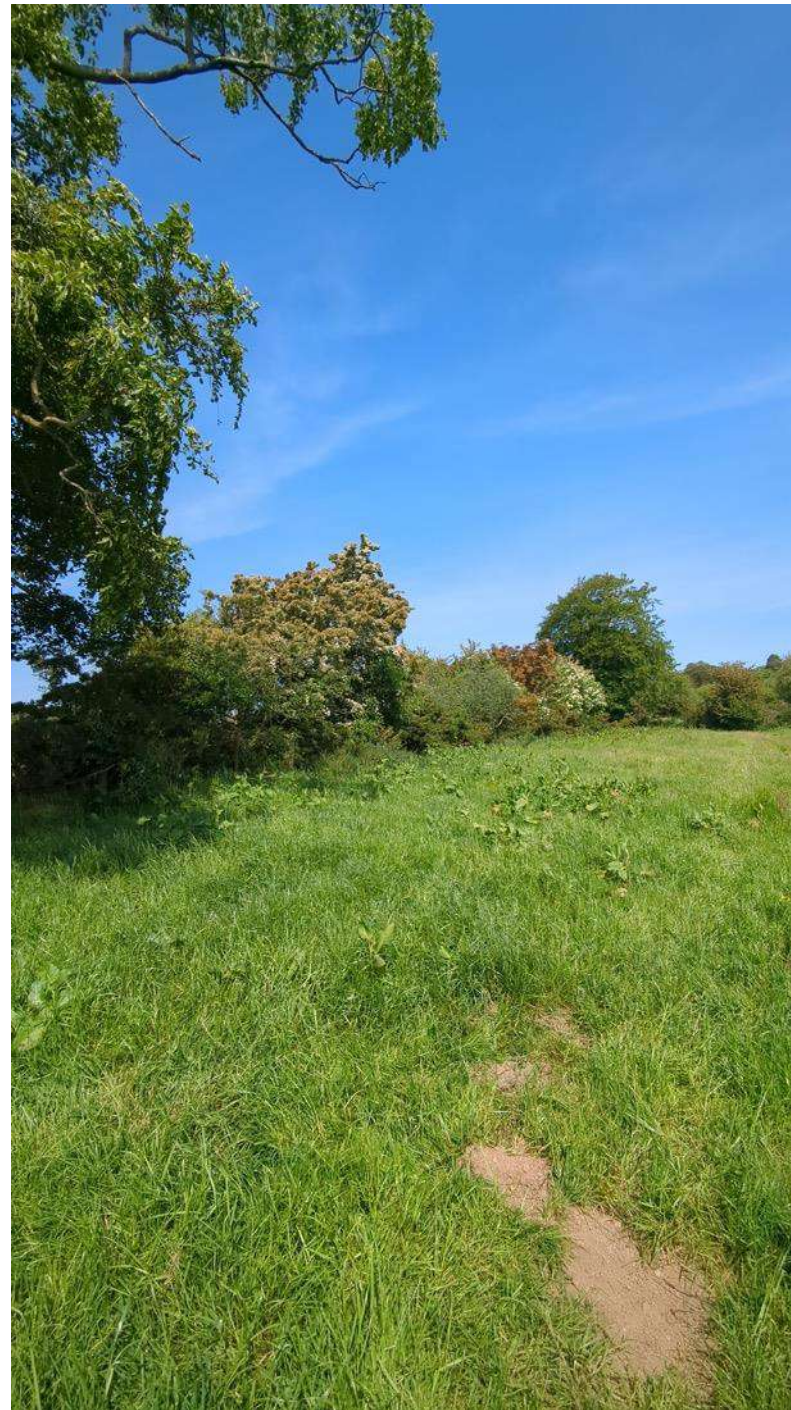
BS_050623 Coylton Substation Image No 02

7.3.1 G3 is an integrated and well-functioning screening line of Hawthorn, Elder & Gorse, with a single substantial Beech specimen (No 7905) featured. The group is in reasonably good condition and is graded in the survey and Retention Category B2, as are all of the individually recorded constituent specimens (Nos 7905–7910). See Image No 02 at Appendix 1, below.

Tree group G3

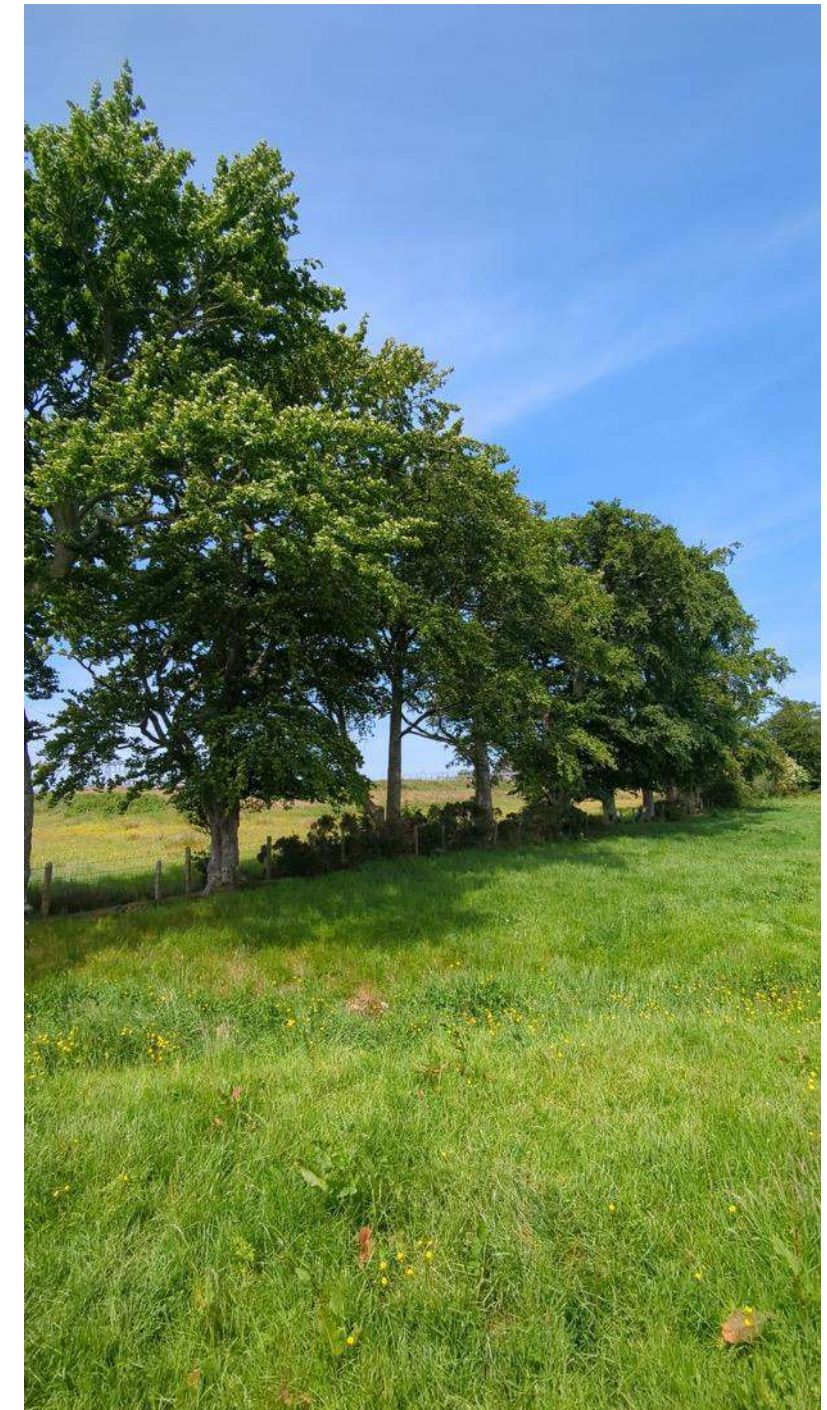
BS_050623 Coylton Substation Image No 03

7.3.2 Group G4 comprises a linear group of mature Beech specimens in (relatively) formal profile. Despite a significant incidence of structural impairments associated with the exposed location, most of these trees are in reasonably good overall condition and are recorded in the survey at Retention Category B2, as is the group as a whole. See Image No 03 at Appendix 1, below.

Tree group G4

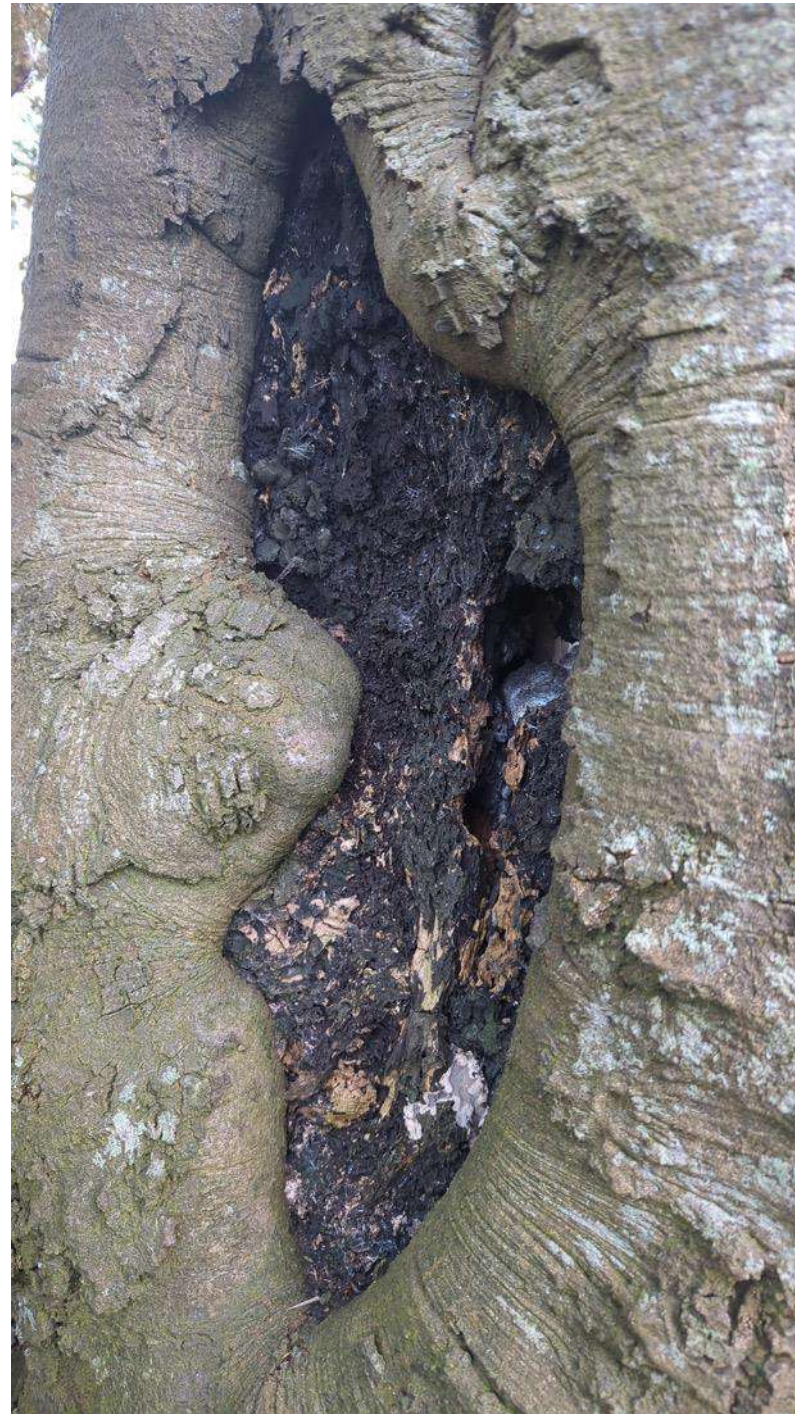
BS_050623 Coylton Substation Image No 05

Stem cavity in tree No 7916 colonised by with *Kretzschmaria deusta* fungus

Tree Reference Number	Grid Reference	Species, Taxa	Age Class	Height (m)	Stem Diameter (mm)	Constituent Stem Diameter of Multistem sps (mm)	Crown Spread (m)	Height (m) and Direction of Lowest Branch	Crown Clearance (m)	Root Protection Area	Physiological Condition	Structural Condition	Condition Notes	Preliminary Management Recommendations	Timeframe for Recommended Works	Estimated Remaining Contribution	BS5837 Retention Category	Photo Reference
7915	NS 46454.41 19562.65	Common Beech, <i>Fagus sylvatica</i>	Mature	15	790	—	N:4 E:7 S:5 W:7	2.5(NE)	2	Radius: 9.5m. Area: 284 sq m.	Fair	Fair	Sited at top of W-facing watercourse embankment beyond site perimeter fence Crown development slightly suppressed from N 2 co-dominant stems from 2.0m via compression union Basal epicormic growths	—	—	20+ Years	B2	—
7916	NS 46455.99 19554.76	Common Beech, <i>Fagus sylvatica</i>	Mature	15	750	—	N:5 E:5 S:4 W:5	9(E)	9	N/A: Retention Category U	Poor	Poor	Sited at top of W-facing watercourse embankment specimen presenting stress symptoms with crown density reduced 2 co-dominant stems from 2.5m via compression union Branch fracture point on NW co-leader with associated internal decay column Trunk wound in NW sector from 0.3 to 0.8m with <i>Kretzschmaria deusta</i> fungus colonising wound	—	—	0 Years	U	Image No 05

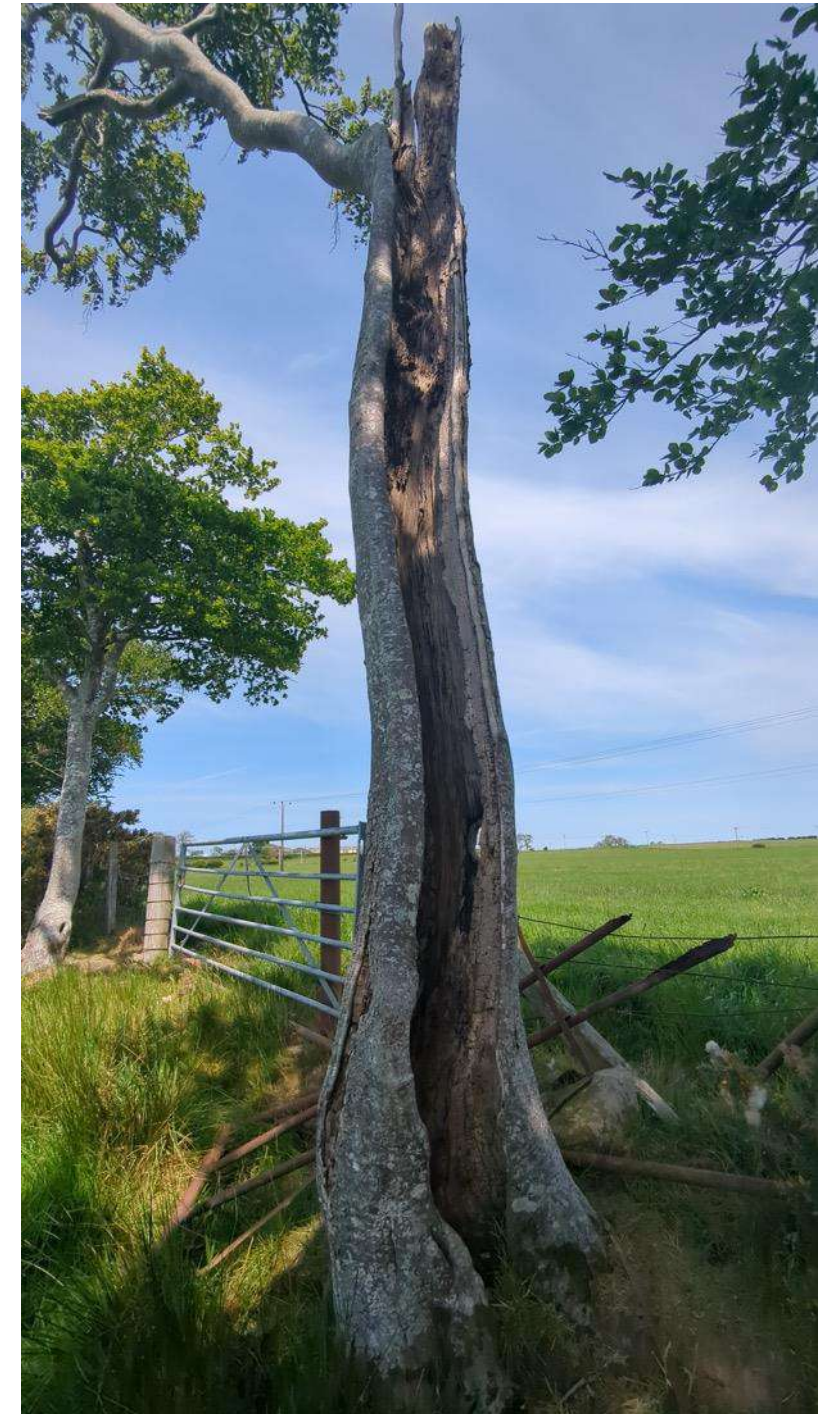
BS_050623 Coylton Substation Image No 06

Tree No 7942 -example of specimens in group G5 featuring major structural defects

7942	NS 46487.58 19381.57	Common Beech, <i>Fagus sylvatica</i>	Mature	10	390	—	N:5 E:1 S:0 W:2	9(NW)	9	Radius: 4.7m. Area: 69 sq m.	Poor	Poor	Moribund specimen with stem having failed leaving extensive decay column from 5.0m to ground level	—	—	<10 Years	C2	—
7943	NS 46488.27 19377.87	Common Beech, <i>Fagus sylvatica</i>	Mature	13	—	490, 190	N:5 E:6 S:5 W:6	2.5(E)	2.5	Radius: 6.3m. Area: 125 sq m.	Fair to Good	Fair to Good	Centre of crown slightly sparse 2 co-dominant stems from 0.5m via compression union	—	—	20+ Years	B2	—
7944	NS 46492.24 19359.22	Common Beech, <i>Fagus sylvatica</i>	Mature	12	700	—	N:5 E:7 S:4 W:5	2.5(SE)	2	Radius: 8.4m. Area: 222 sq m.	Fair to Poor	Fair	Large bark wound from branch tearout in S sector with some wound-wood developing Specimen presenting depleted vigour with sparse crown and apical dieback of branch extensions	—	—	10+ Years	C2	—
7945	NS 46494.15 19347.55	Common Beech, <i>Fagus sylvatica</i>	Mature	7	540	—	N:2 E:2 S:3 W:1	2(E)	2	Radius: 6.5m. Area: 133 sq m.	Poor	Poor	Main stem failed with extensive associated bark damage and decay column with inadequate wound-wood developing	—	—	<10 Years	C2	—

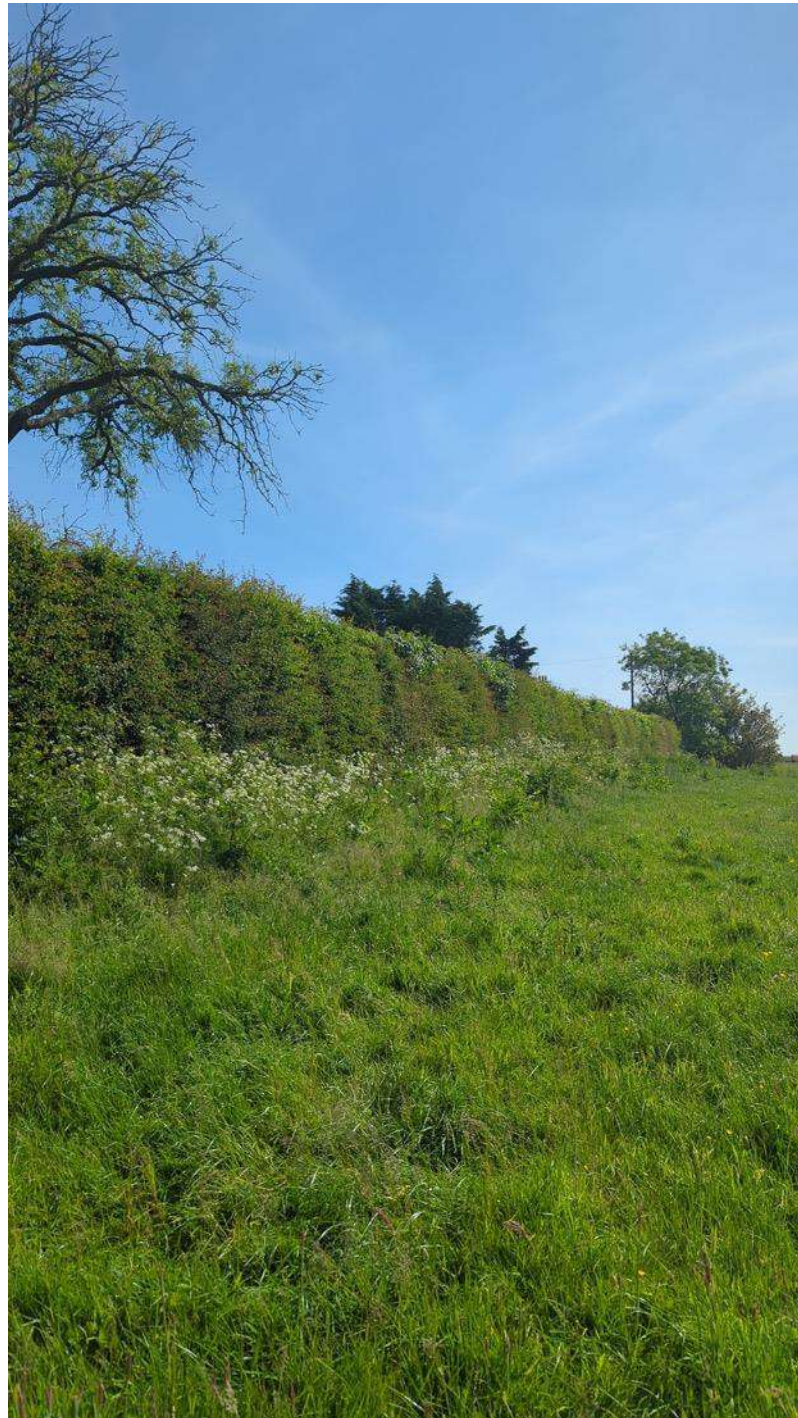
BS_050623 Coylton Substation Image No 07

7.5.1 H1 is a mixed-species broadleaf hedge, maintained to formal profile and in good overall condition, graded at Retention Category B2. See Image No 07 at Appendix 1, below. It is anticipated that a section of this hedge will be removed to facilitate the construction of an access road into the application area, and will be lost to the proposed development.

Hedge H1

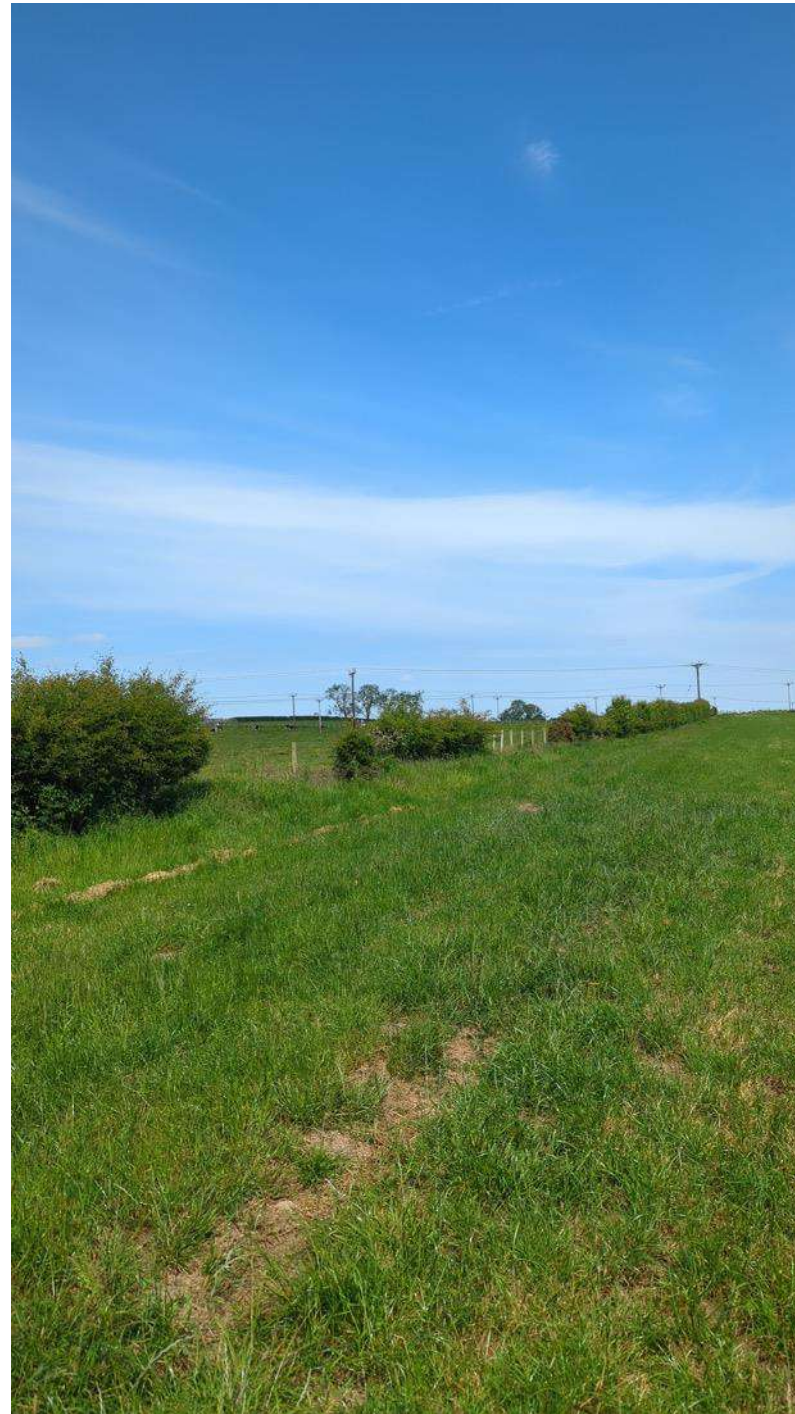
BS_050623 Coylton Substation Image No 08

7.5.2 H2 is composed entirely of Hawthorn. It features a number of gaps in the central sector, but is otherwise reasonably well-functioning and graded at Retention Category B2. See Image No 08 at Appendix 1, below.

Hedge H2 showing gaps in central sector

Hedges																		
H1	NS 46620.30 19815.09	Common Beech, <i>Fagus sylvatica</i> Common Hawthorn, <i>Crataegus monogyna</i> European Ash, <i>Fraxinus excelsior</i>	Mature	<2	<50	—	—	—	—	Area: 402 sq m.	Good	Good	Formal mixed-species boundary hedge maintained at 2.0m on northern perimeter of site In good overall condition and well-integrated throughout with no gaps	—	—	40+ Years	B2	Image No 07
H2	NS 46598.57 19589.25	Common Hawthorn, <i>Crataegus monogyna</i>	Mature	<2	<50	—	—	—	—	Area: 863 sq m.	Fair to Good	Fair to Good	Linear maintained Hawthorn hedge running W to E Locally dense in E and W sectors with central sector featuring substantial gaps	—	—	20+ Years	B2	Image No 08

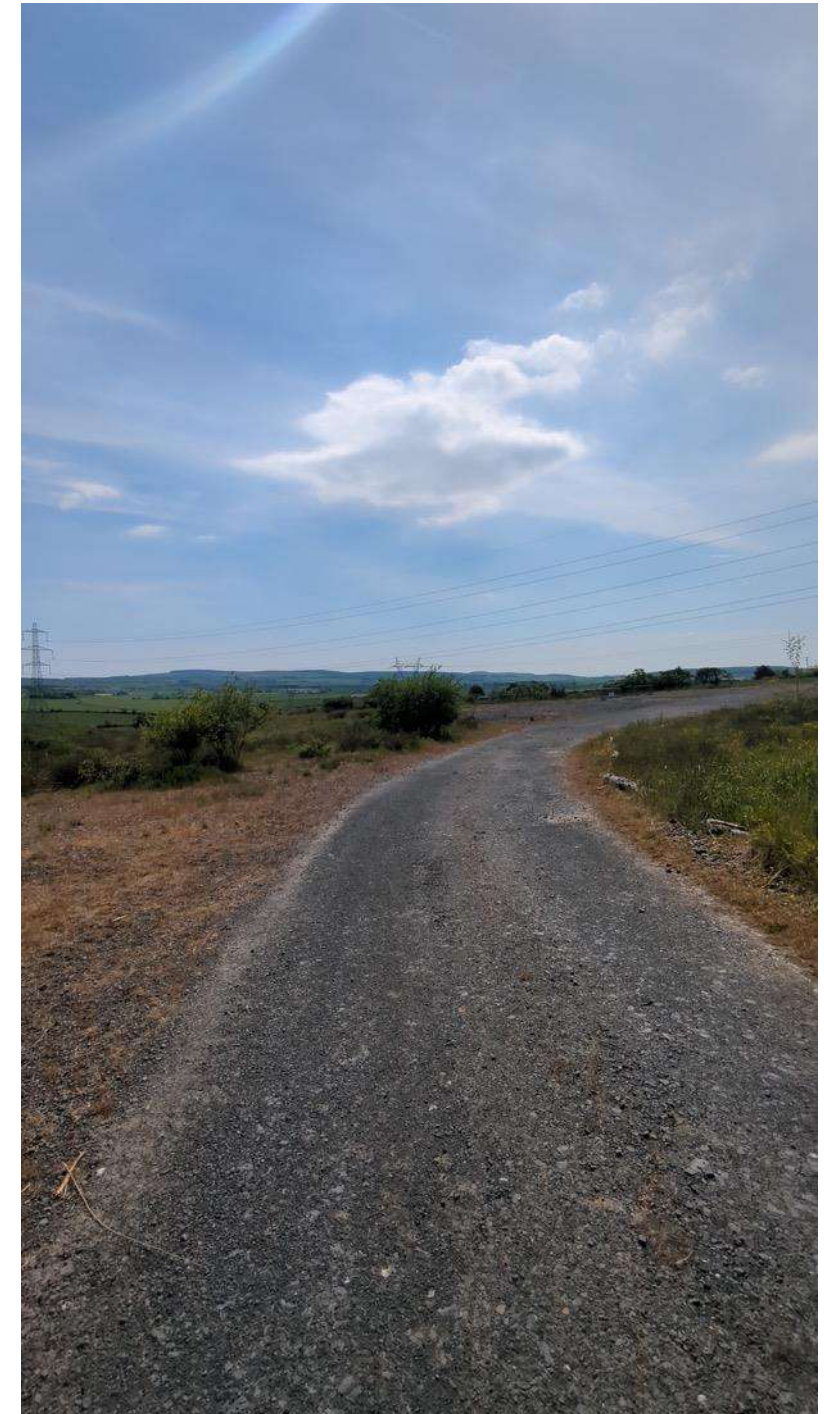
BS_050623 Coylton Substation Image No 09

7.6.1 CA1 defines an area of Willow scrub to the south of the substation. Constituent trees are of modest proportions and the area is graded at Retention Category C2, although the ecological value of this scrubland is reasonably high. See Image No 09 at Appendix 1, below.

Canopy area CA1 featuring scrub Willow
