**ARBORICULTURAL IMPACT ASSESSMENT
to BS 5837:2012
at
Land at Common Lane
Allerthorpe
East Riding of Yorkshire
YO42 4RL**

16829a/RB – Rev 2

- 1.2.1 JCA Limited has been instructed by **Arcus Consultancy Services Ltd** to prepare an Arboricultural Impact Assessment, based on our Arboricultural Report dated 6th May 2021 (JCA Ref: **16872/EaR**). The arboricultural survey and report conforms to the most recent specifications outlined in BS 5837: 2012 Trees in relation to design, demolition and construction - Recommendations.
- 1.2.2 We have been supplied with **Drawing Ref. 3404_SOAY_DR_PRE_0002G**, which details the proposed development. The tree data has been overlaid onto the proposed designs to create the Arboricultural Implications Plan, which can be found at **Appendix 7**. This provides the basis for which this Arboricultural Impact Assessment has been prepared.

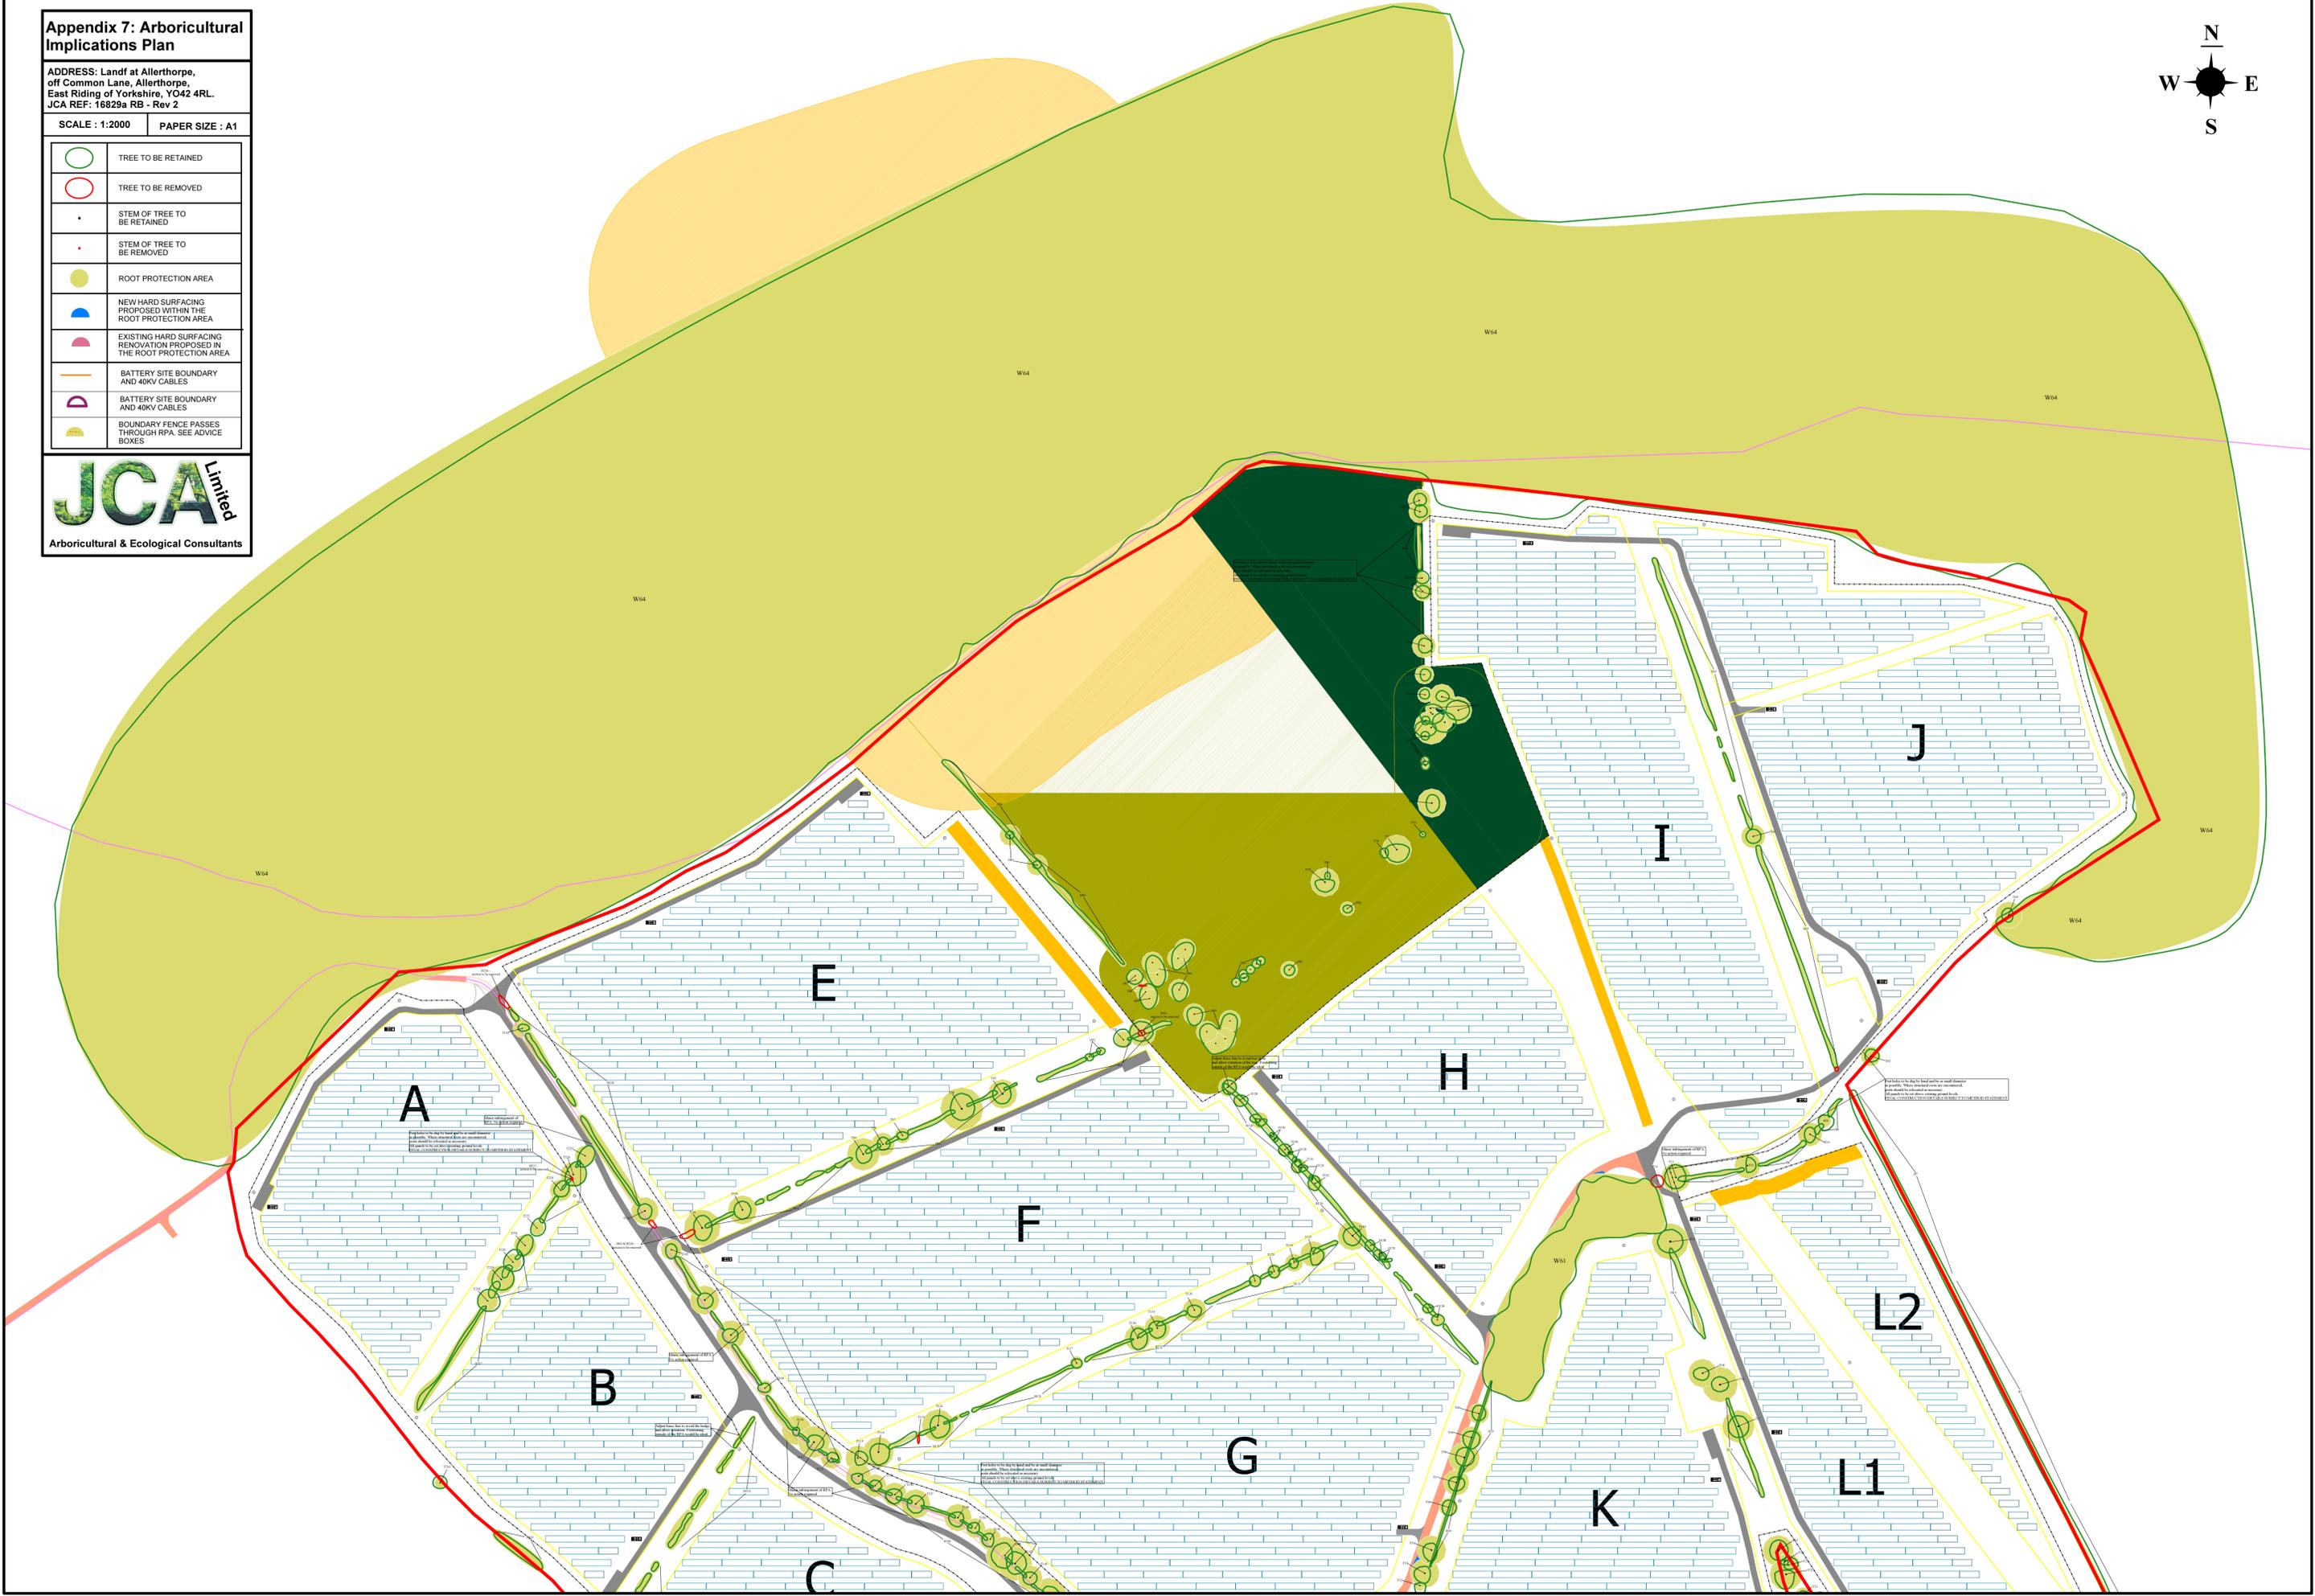
Appendix 7: Arboricultural Implications Plan

BOUNDARY FENCE PASSES THROUGH RPA. SEE ADVICE BOXES

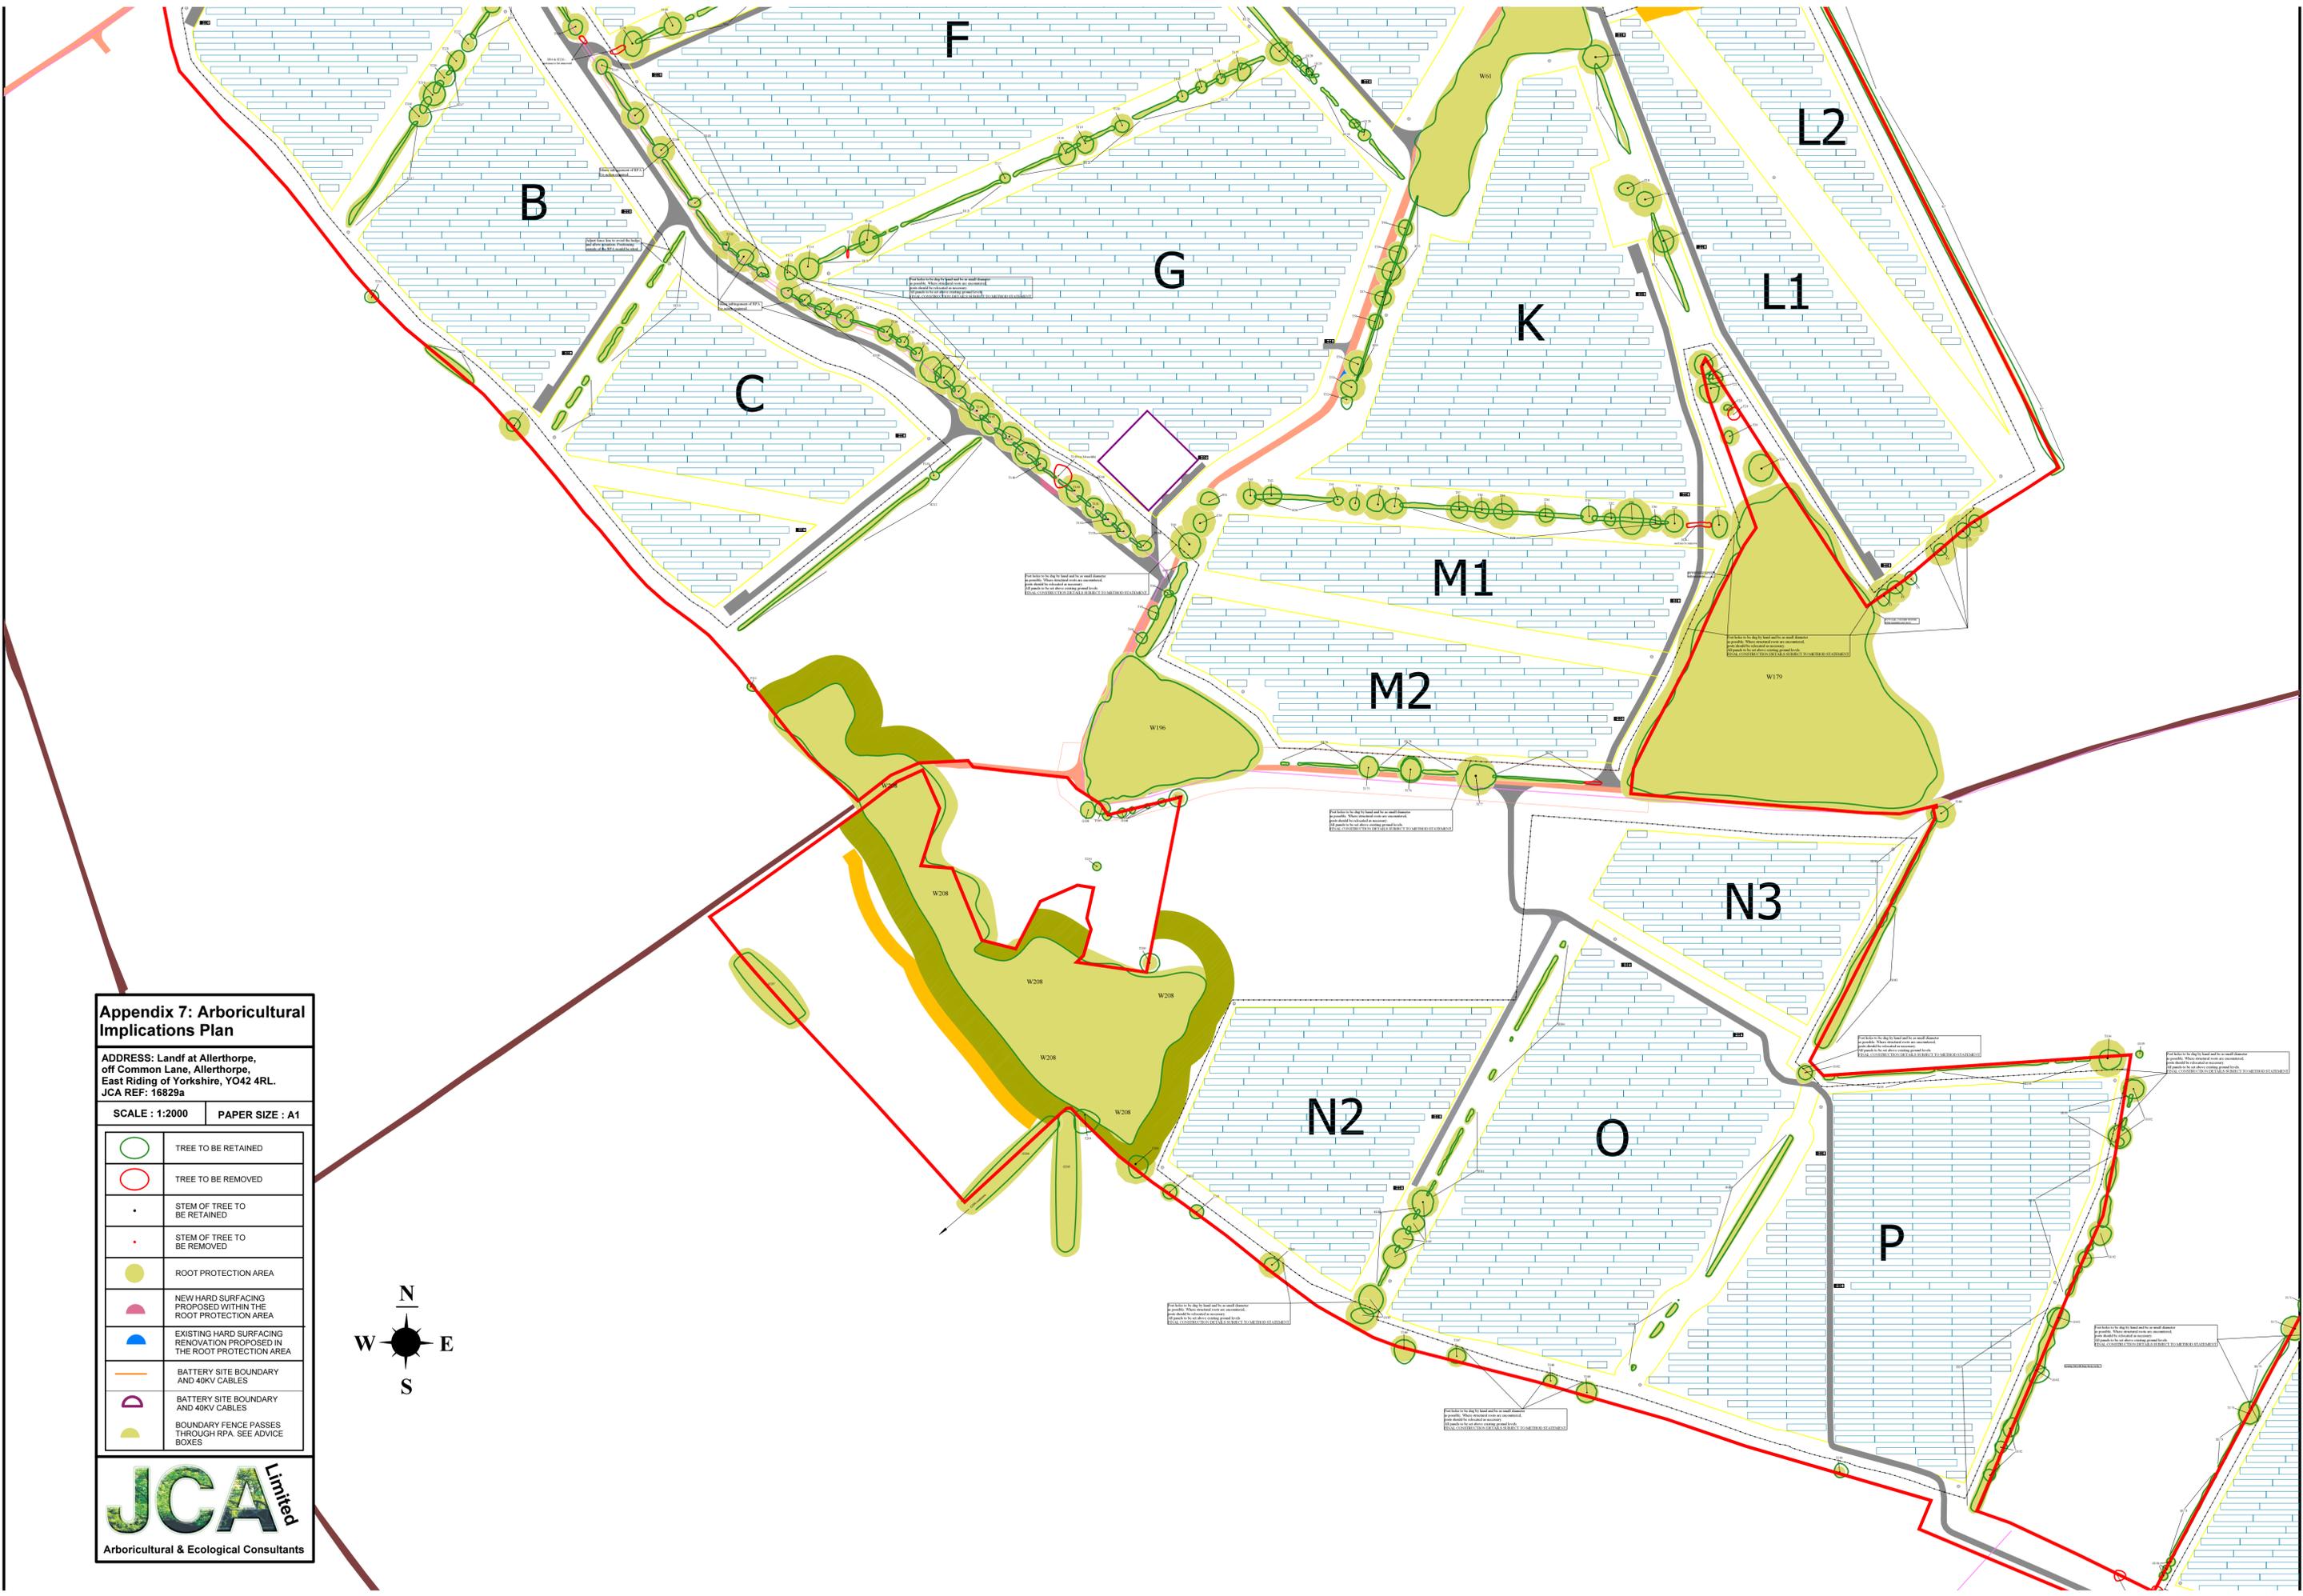
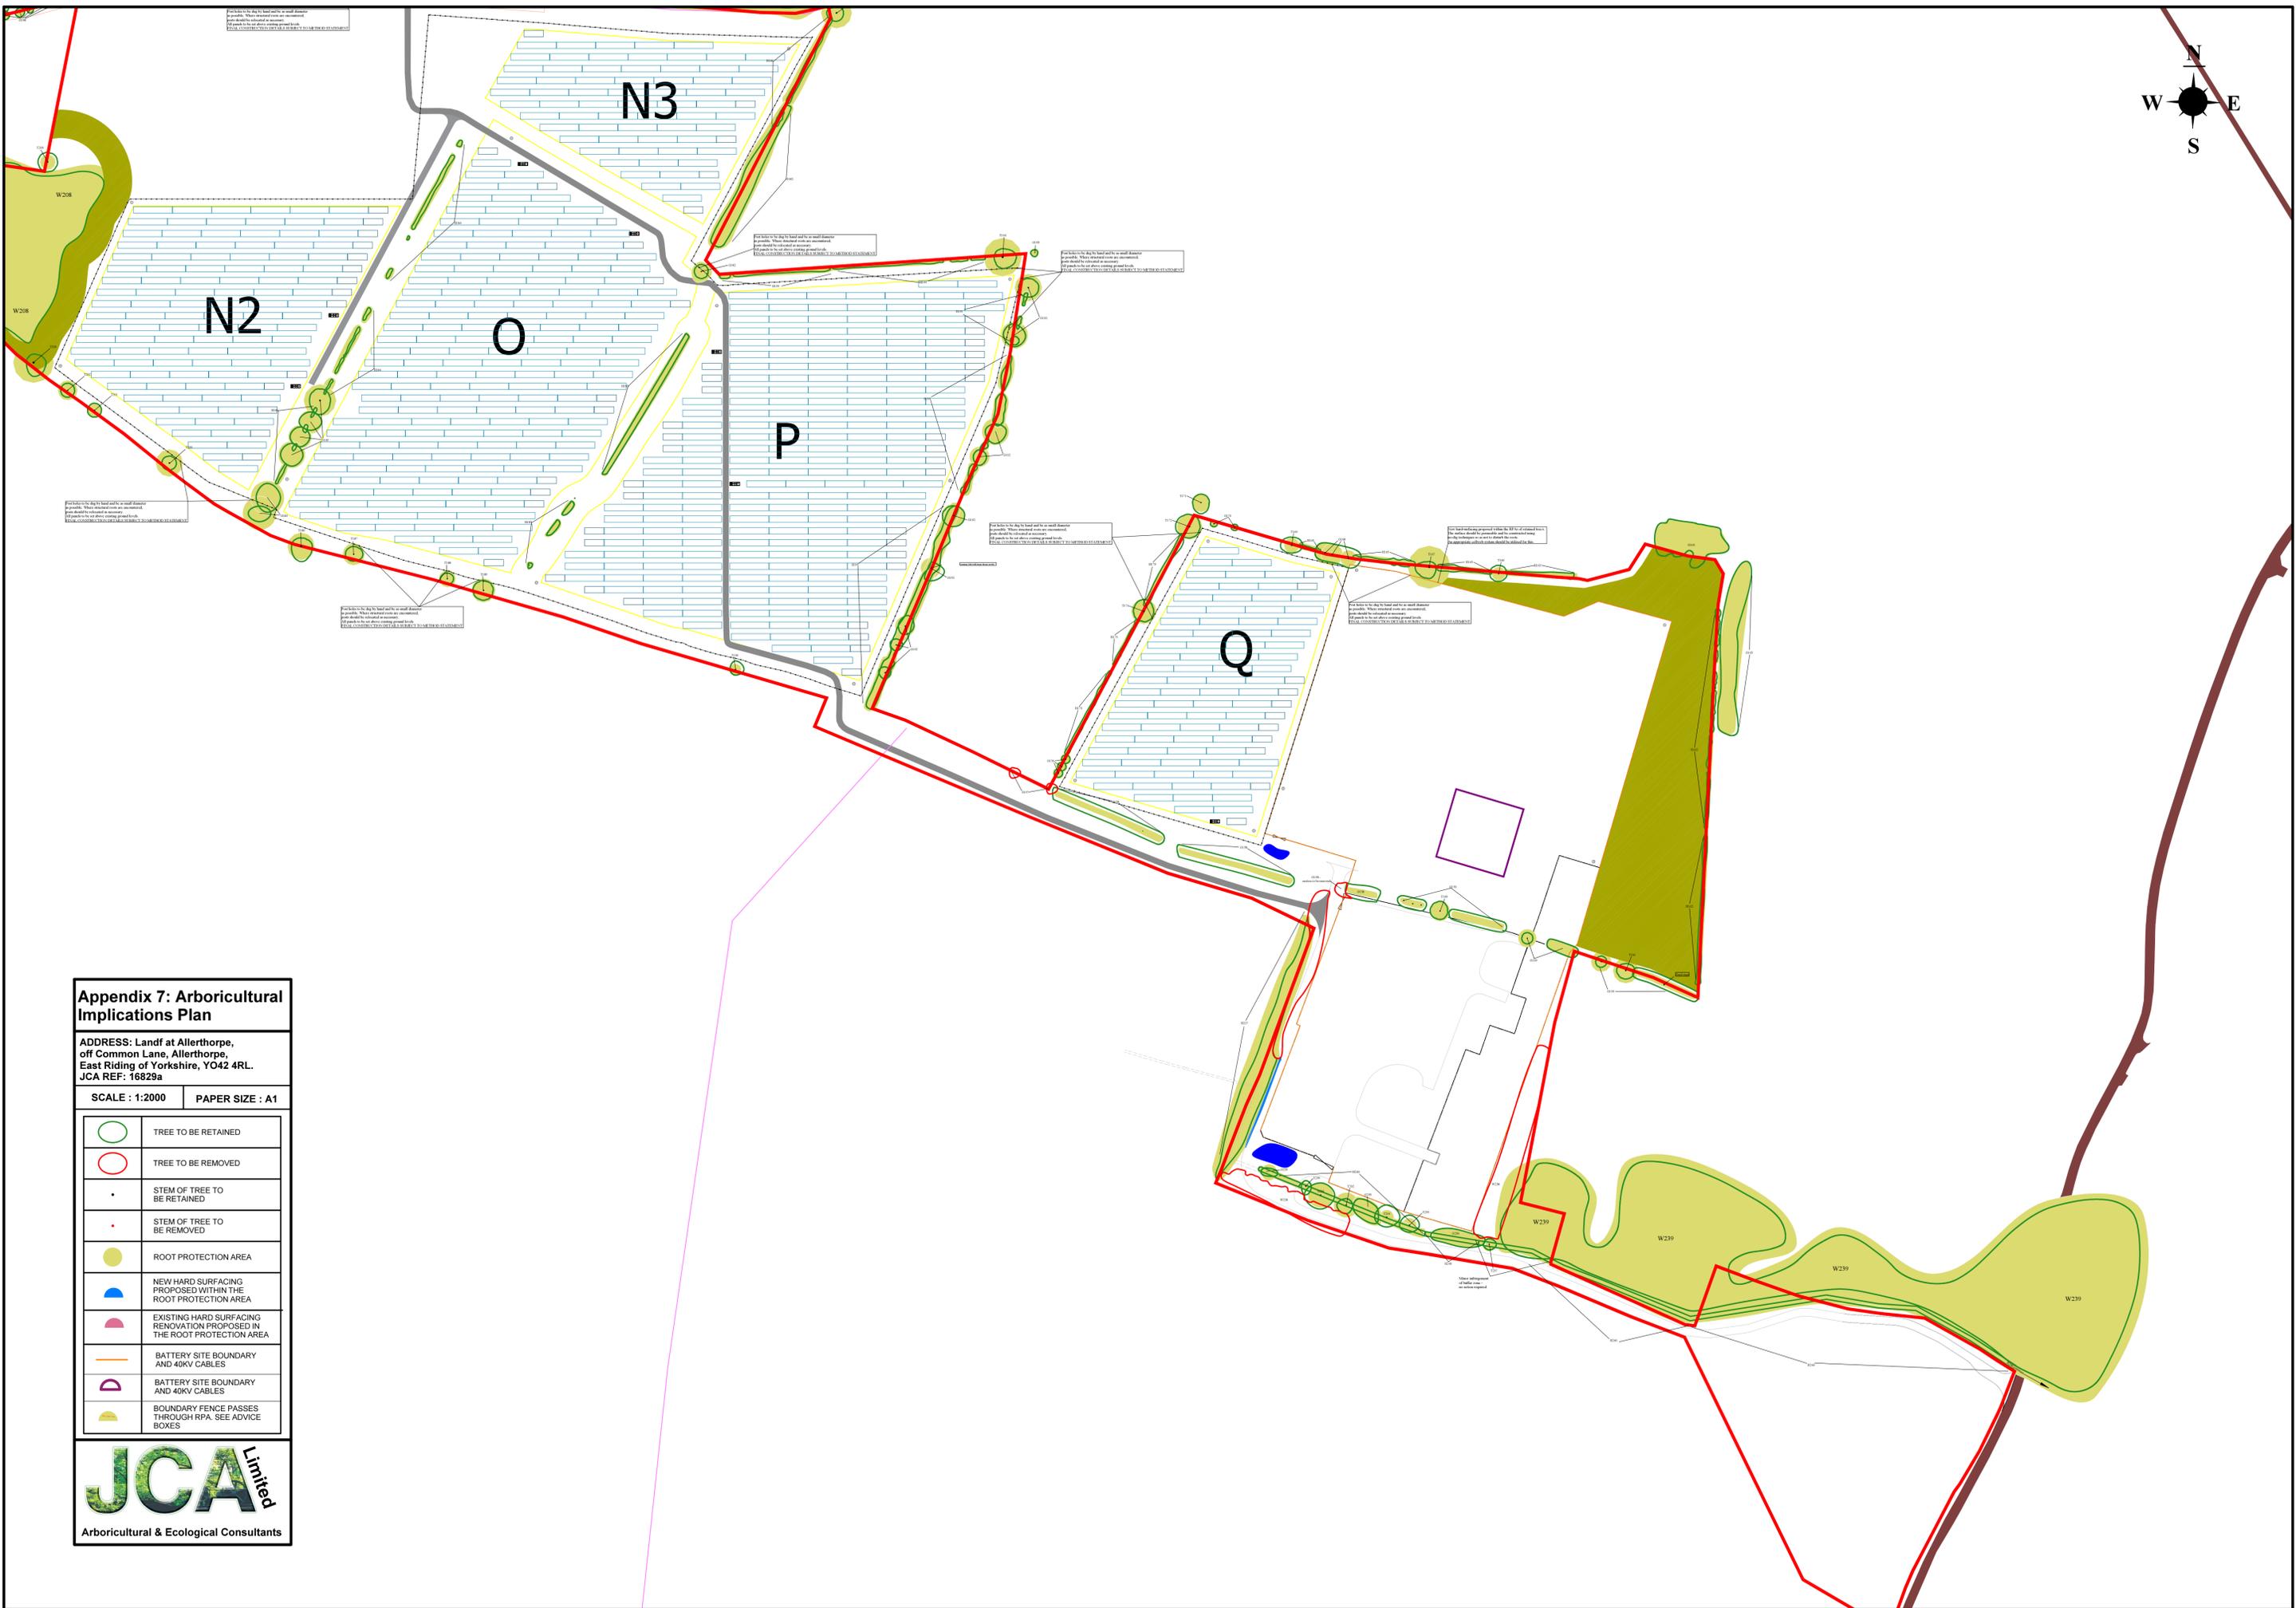
Appendix 7: Arboricultural Implications Plan

BOUNDARY FENCE PASSES THROUGH RPA. SEE ADVICE BOXES
