Knockcronal Wind Farm
Environmental Impact Assessment Report

Figure 3.7

Typical Watercourse Crossing

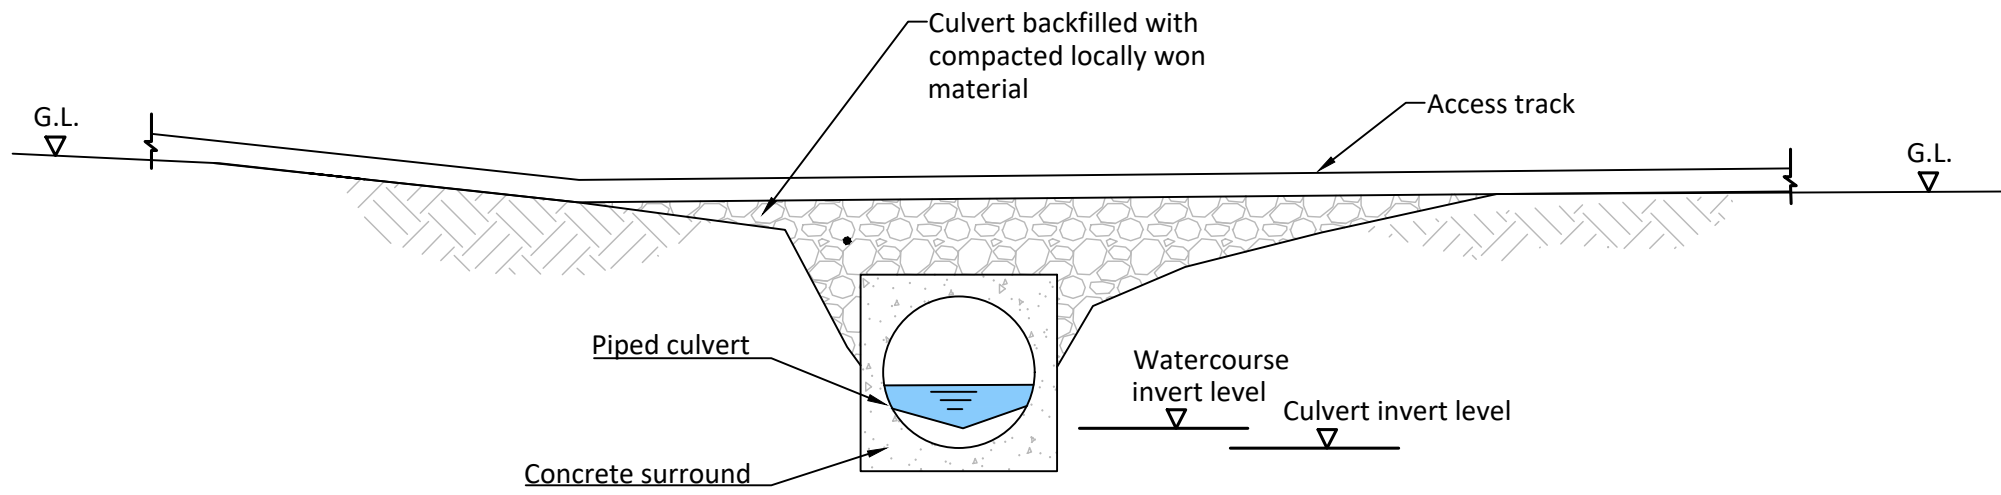
Indicative Piped Culvert

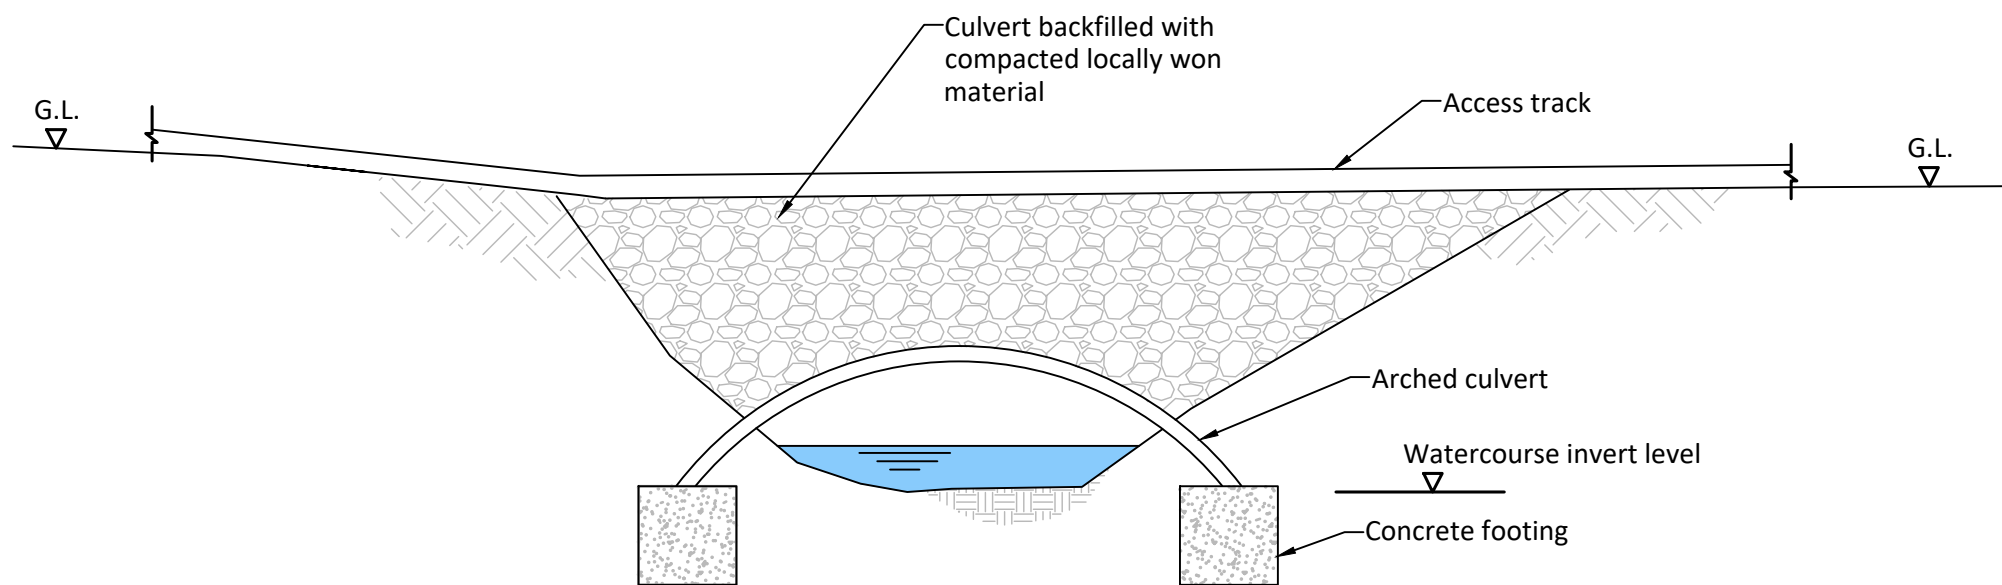
Indicative Bottomless Arched Culvert
