## Appendix 9.4 - Peat Landslide Hazard and Risk Assessment Knockcronal Wind Farm

South Ayrshire, Scotland

20-FEC-013-D-001v01

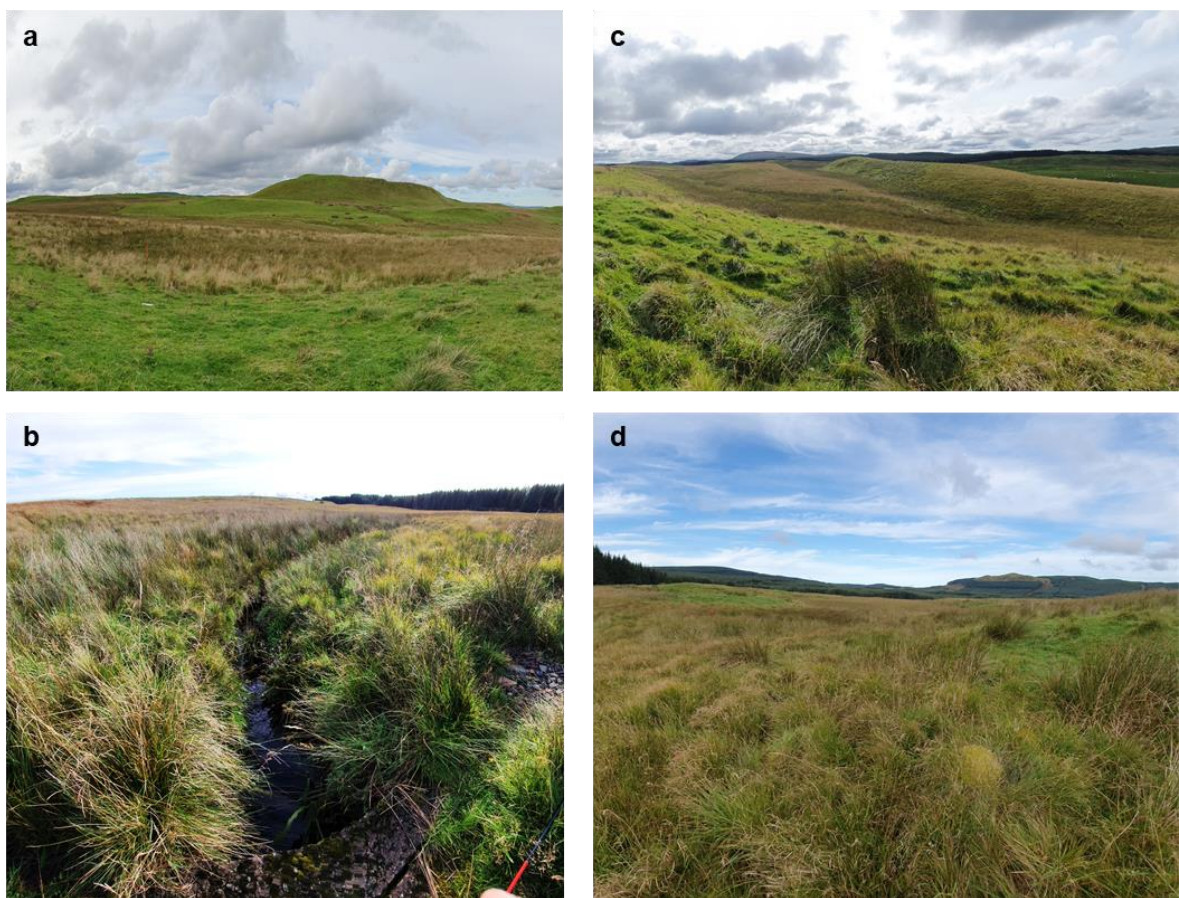
**Plate 3.2 a) Big Benyaw from Halfmark Rig, b) minor tributary of Shiel Burn (with culvert outlet), c) spurs separating Shiel Burn from minor tributaries, d) *Juncus* dominated flush over revegetated drains**

Interpretation of aerial imagery indicates numerous land drains cut into the ground surface (**Figure 9.4.5**), most of which are overgrown (e.g. **Plate 3.2d**). Drains tend to have been cut in flushed areas which now show extensive reed cover.

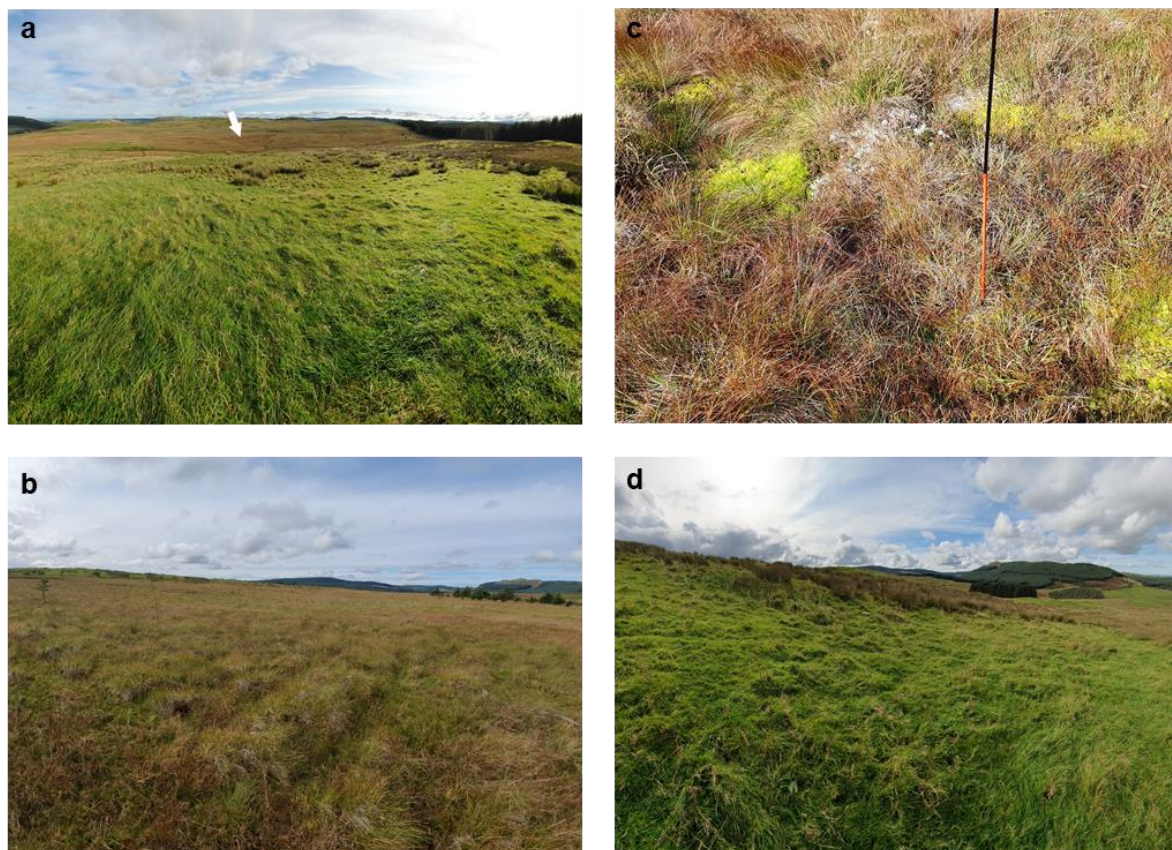
**Plate 3.3 a) saddle with deeper peat (looking NE from Clashverains), b) typical bog vegetation on deep peat area above Craiganstirrup, c) *Sphagnum* in deep peat area east of Clashverains, d) typical non-peat grassland on middle and lower slopes below main turbine area**
